DEBRIS/ICE/TPS ASSESSMENT  
AND  
PHOTOGRAPHIC ANALYSIS  
OF  
SHUTTLE MISSION STS-32R

January 9, 1990

Gregory N. Katnik  
NASA/Kennedy Space Center  
TV-MSD-22

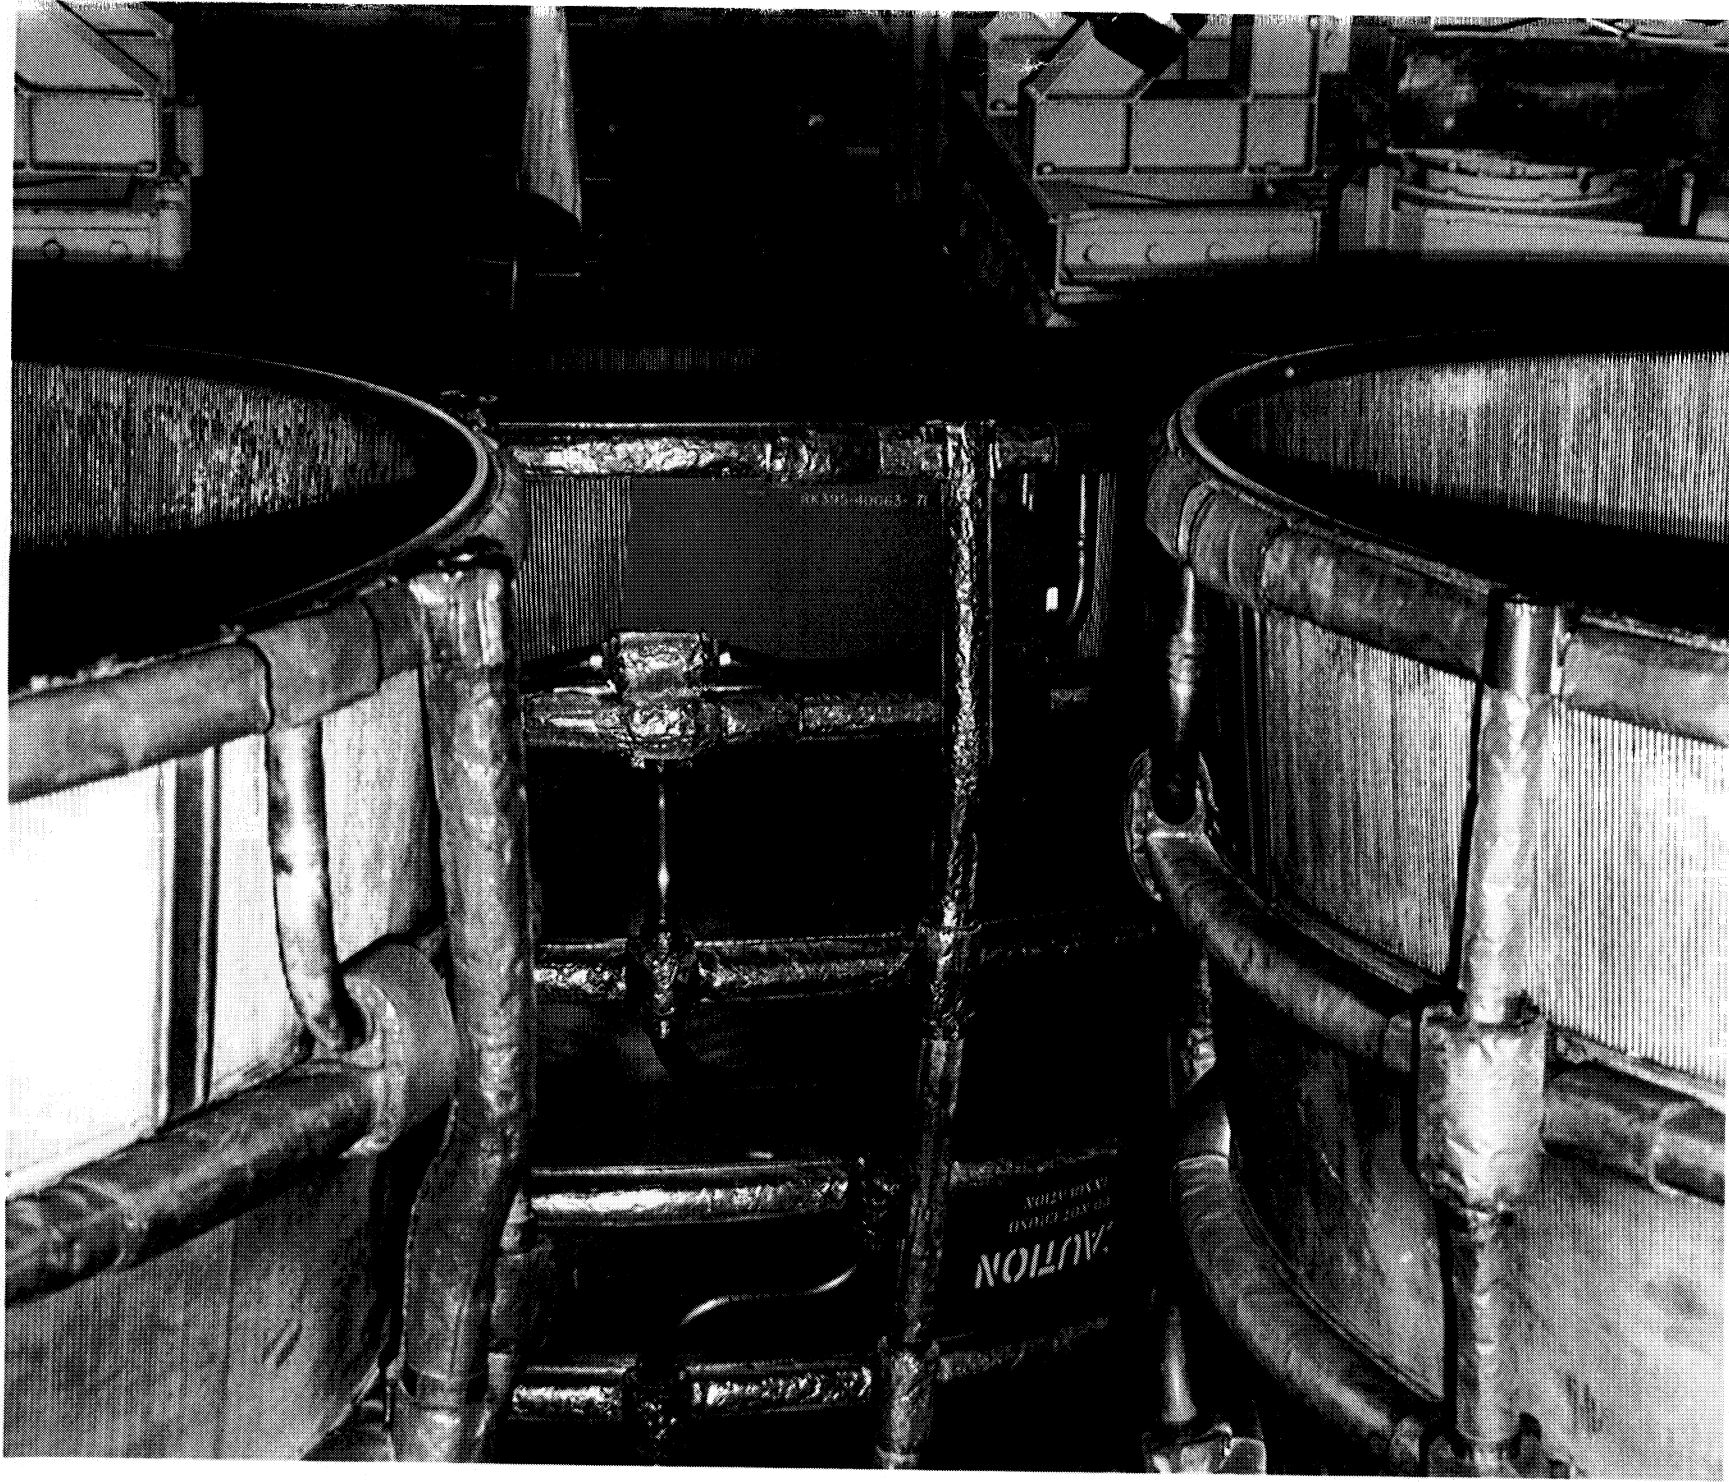
Red GSE cover on SSME #1 was removed prior to cryoload

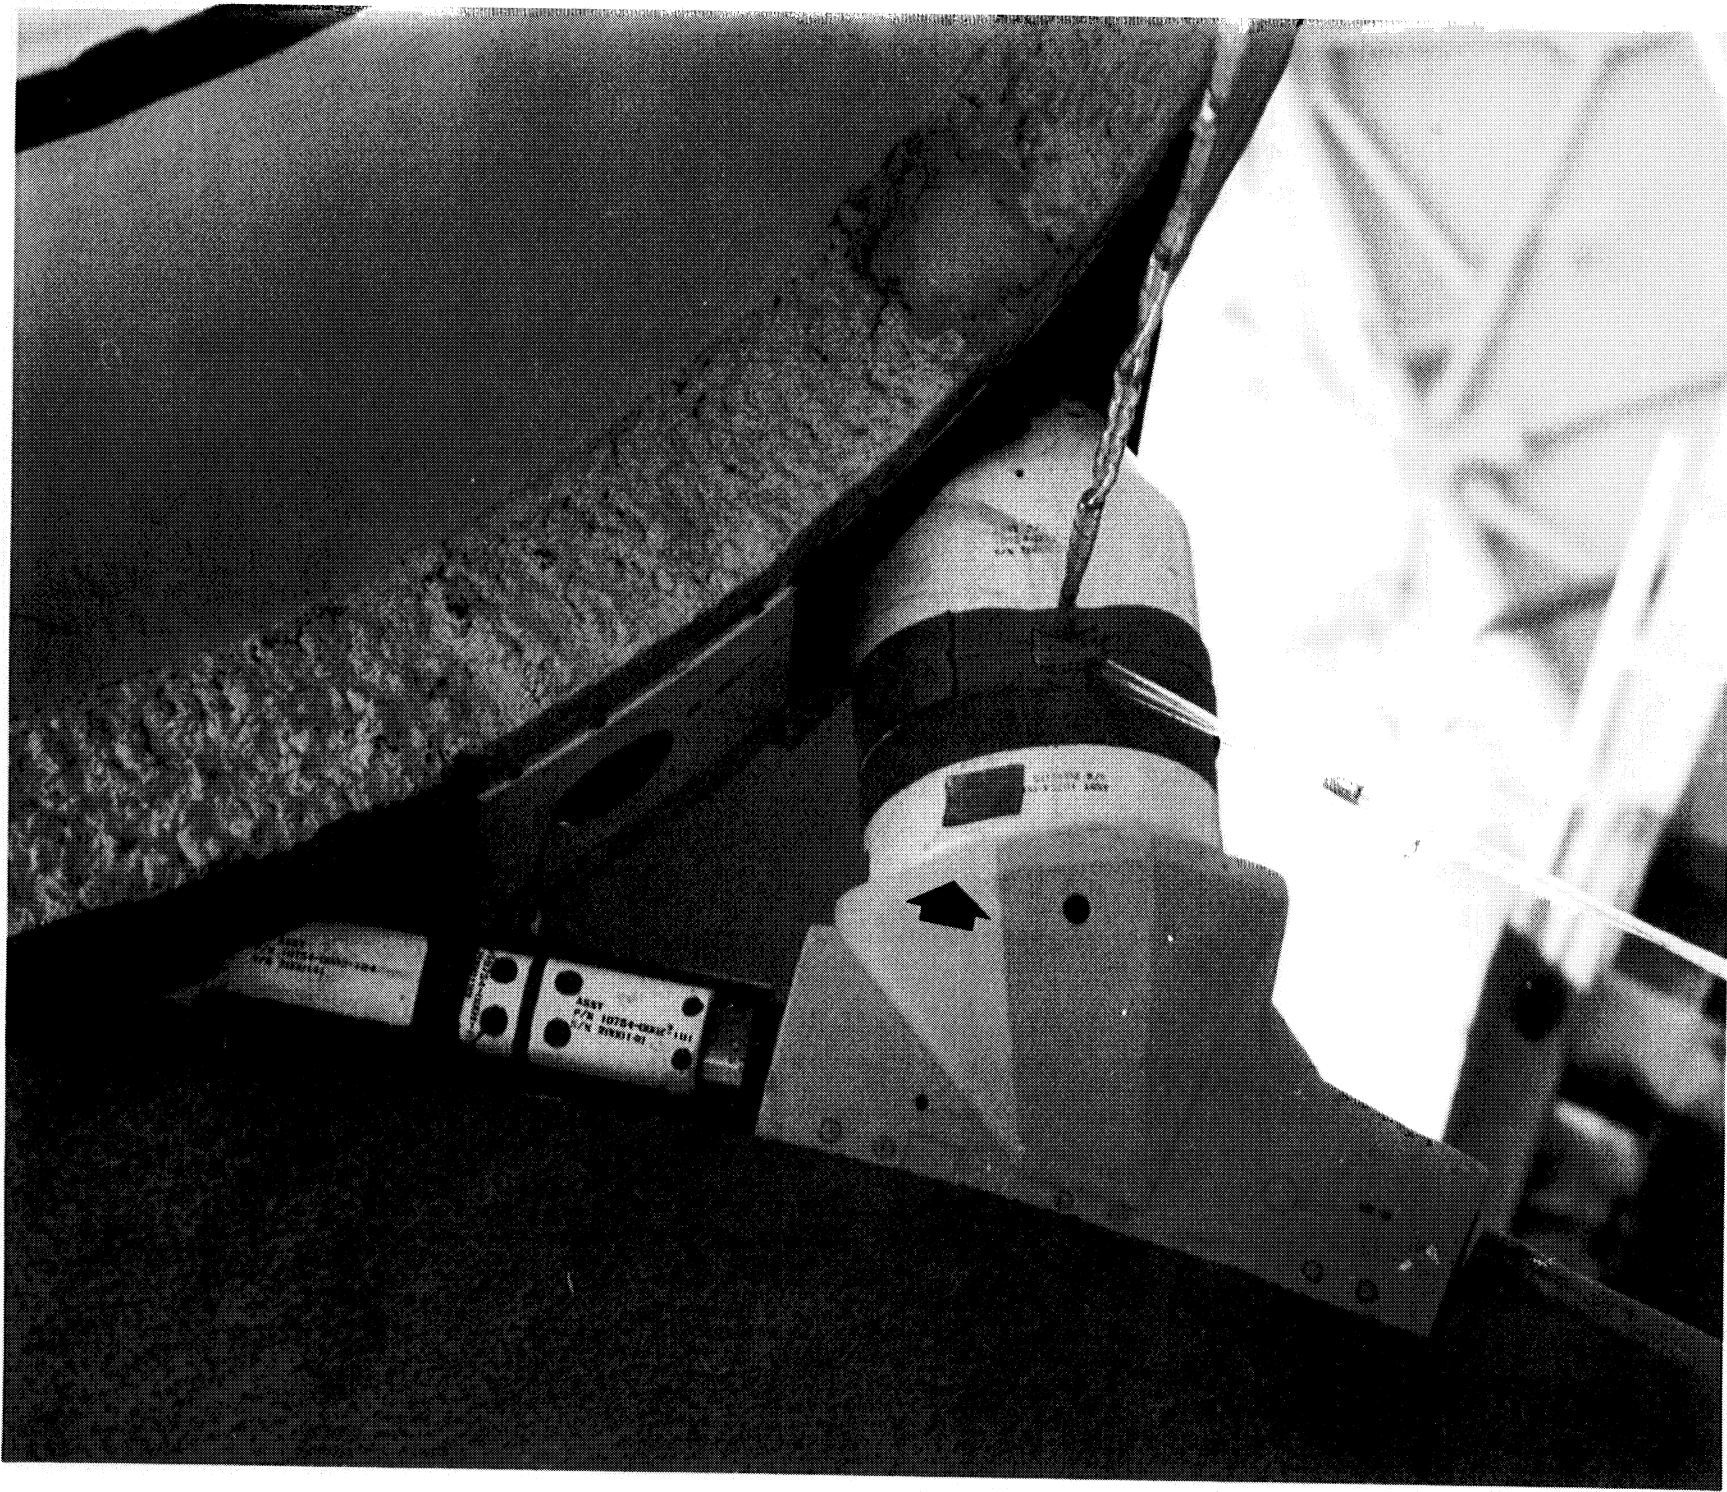
4-inch piece of duct tape of the aft side of the LH upper strut  
fairing remained for flight per MRB approval

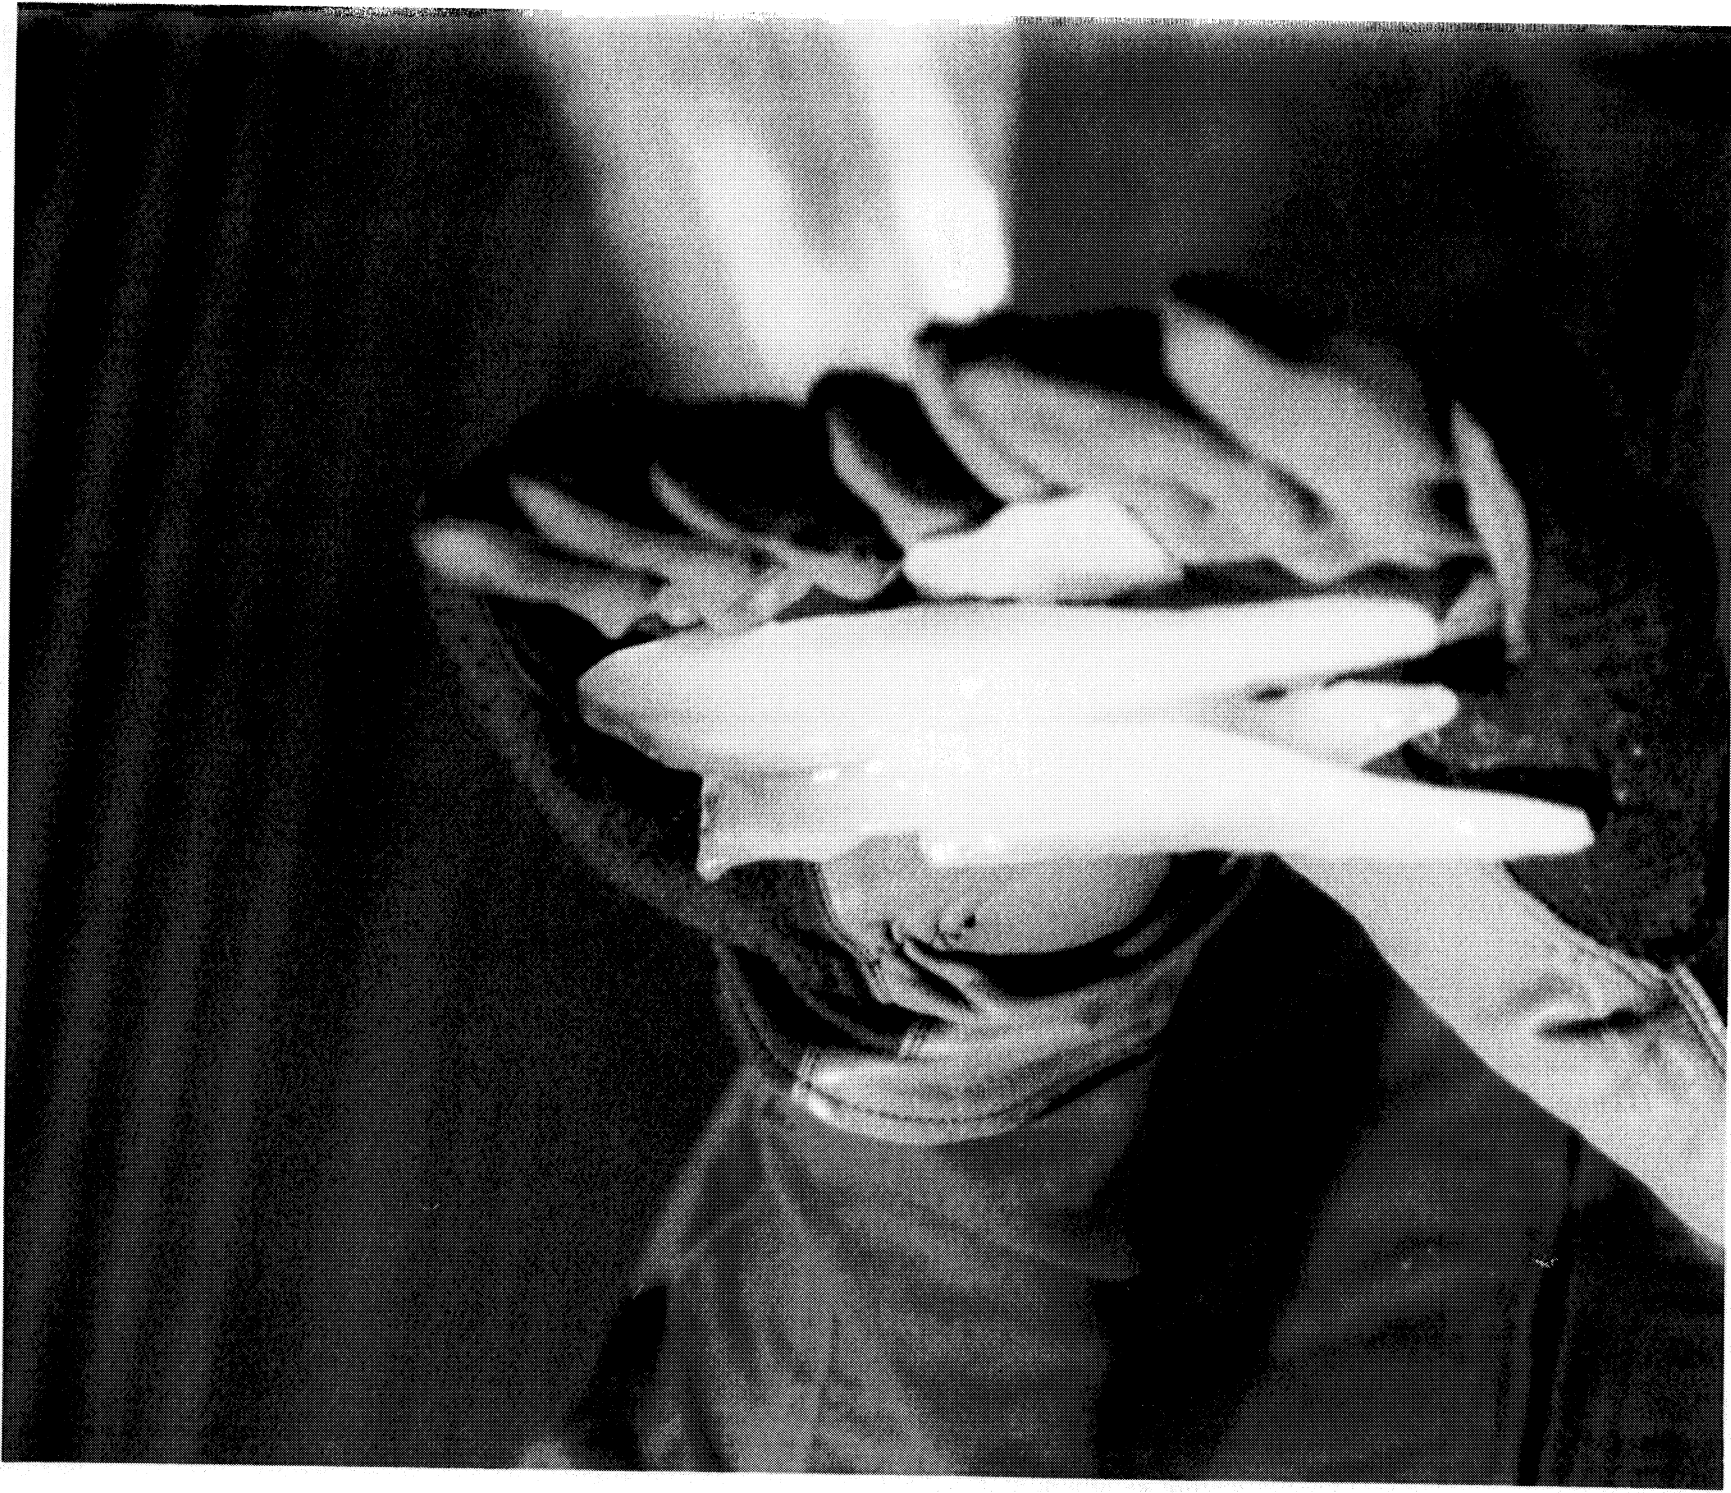
Structural features to prevent icicle formation on the Pad B GOX vent ducts had not been incorporated on Pad A. Hydro diverters, which prevent water and condensate from running to the duct ends and freezing, had not been installed. This had been approved by PR - MRB.

Icicles, with an estimated density of 30 pounds per cubic foot,  
were removed from the north GOX vent duct by the Ice Team

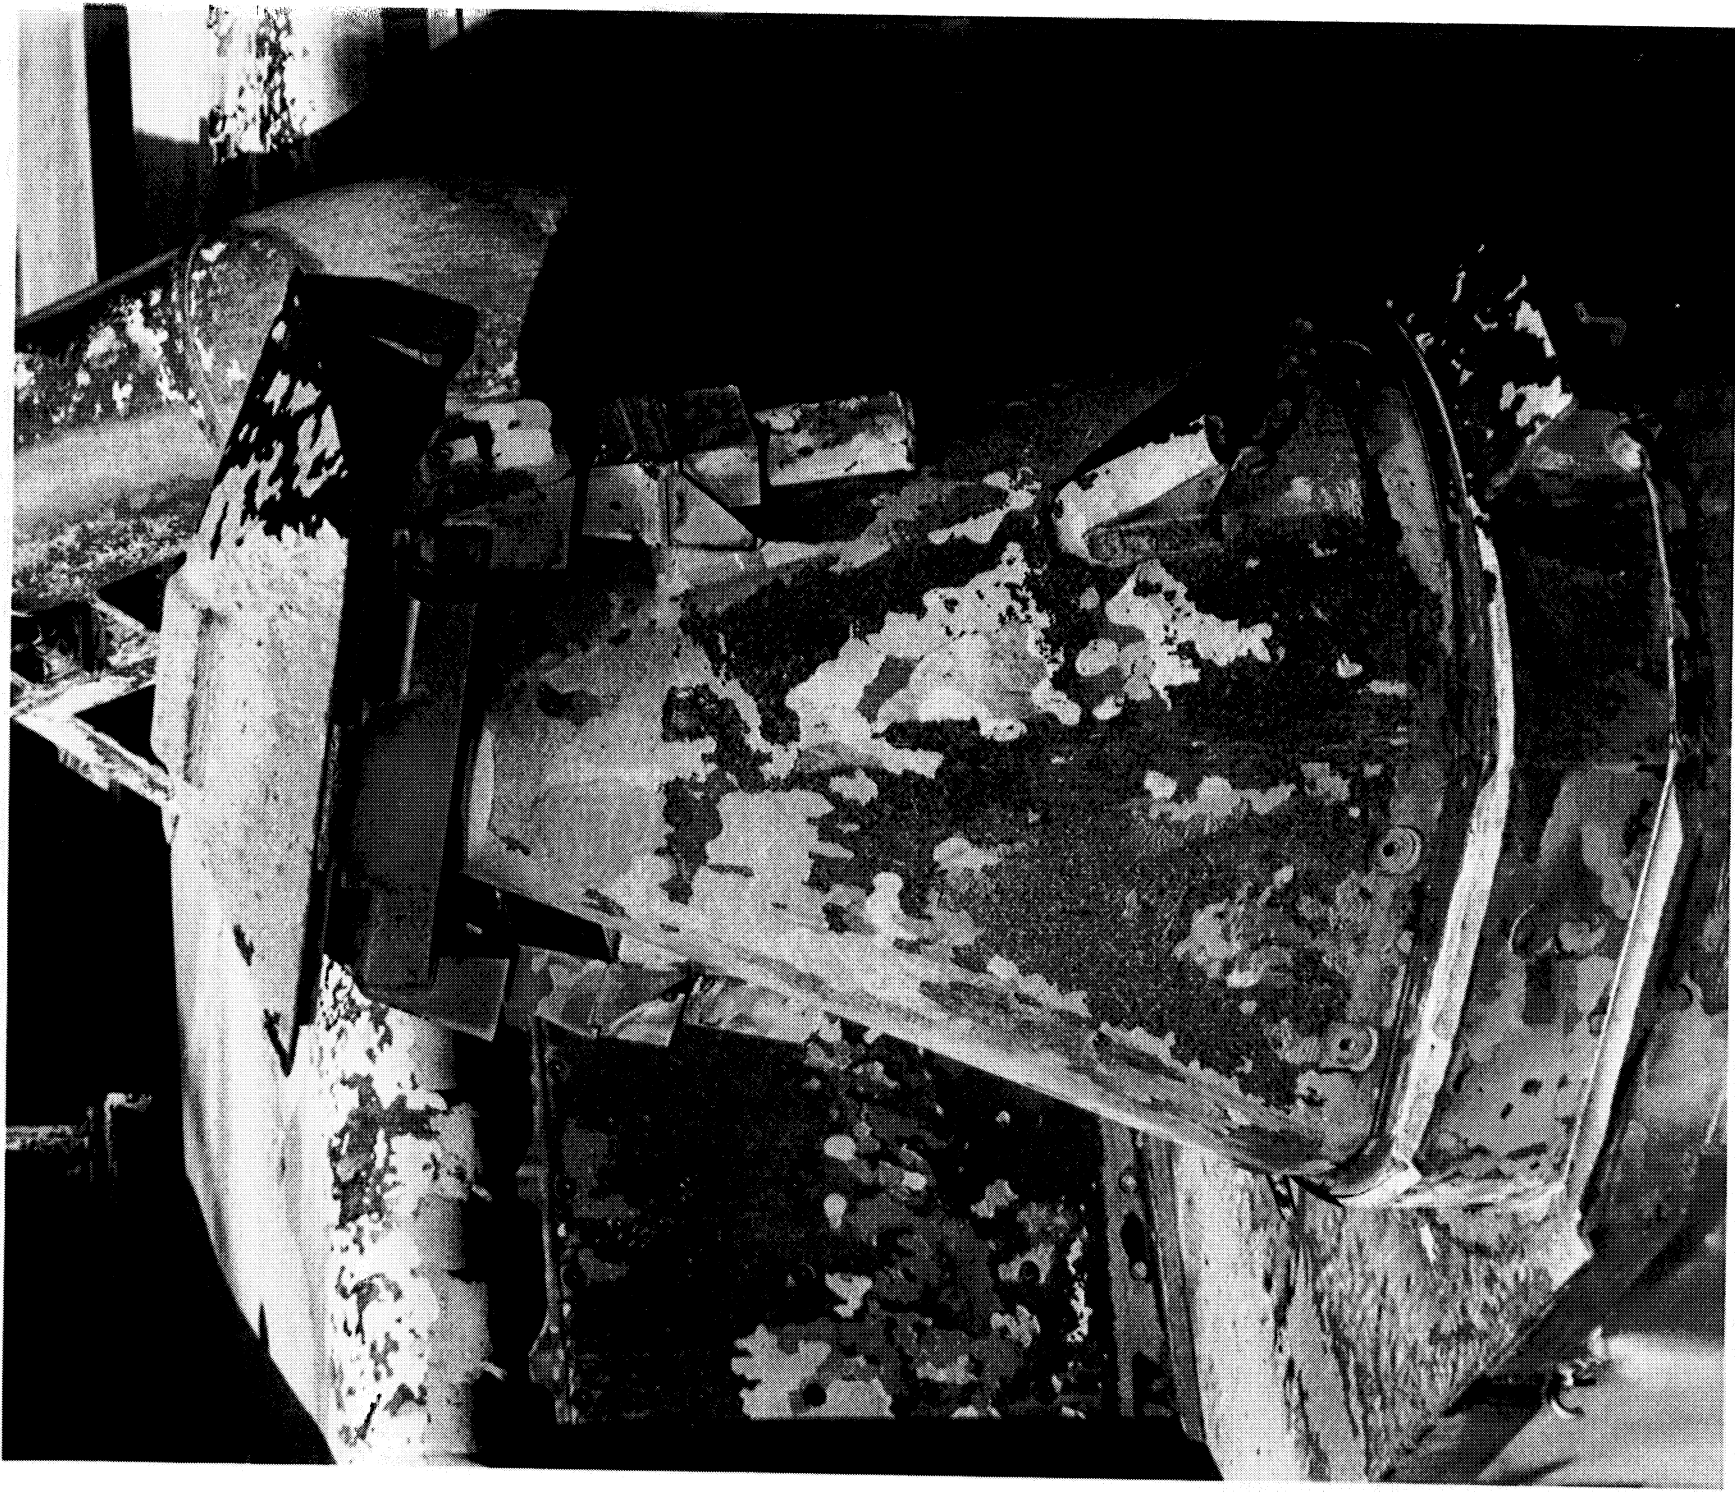
Post launch condition of a north SRB holddown post. All holddown post doghouse blast covers were closed.

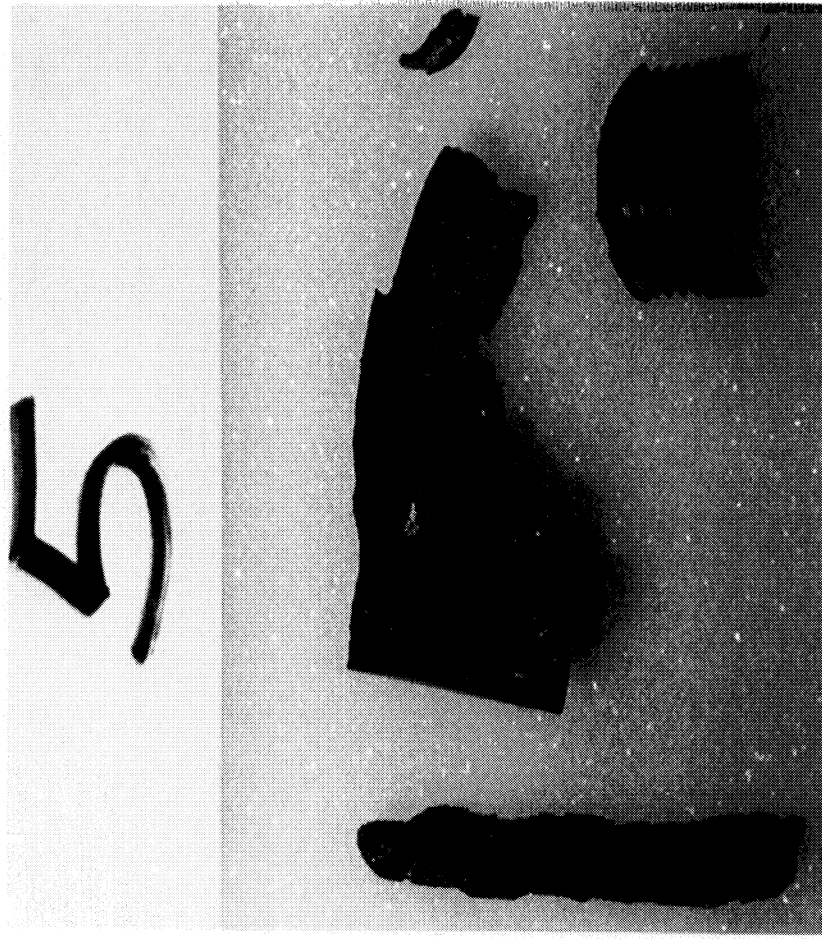
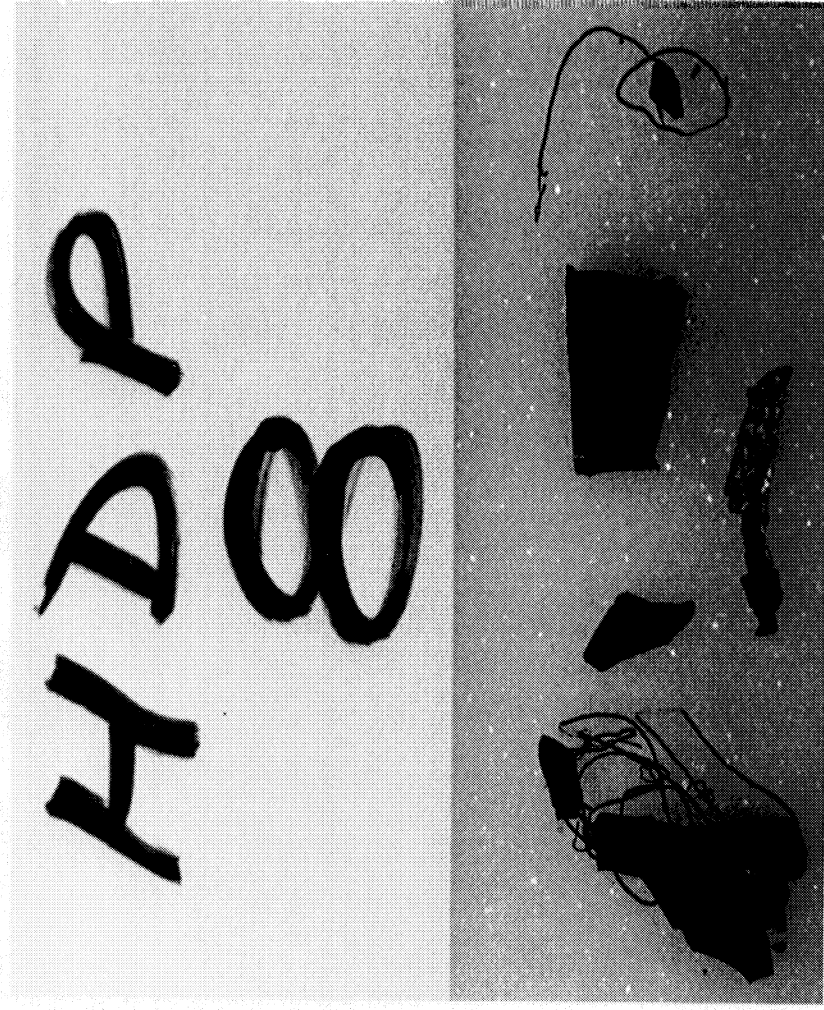
The quantity of DCS debris lost during this launch is considered by the Debris Team to be unacceptable and a potential unnecessary hazard to the vehicle.

Examination of LH SRB holddown post sandboxes revealed  
pieces from NSI cartridges and frangible nuts

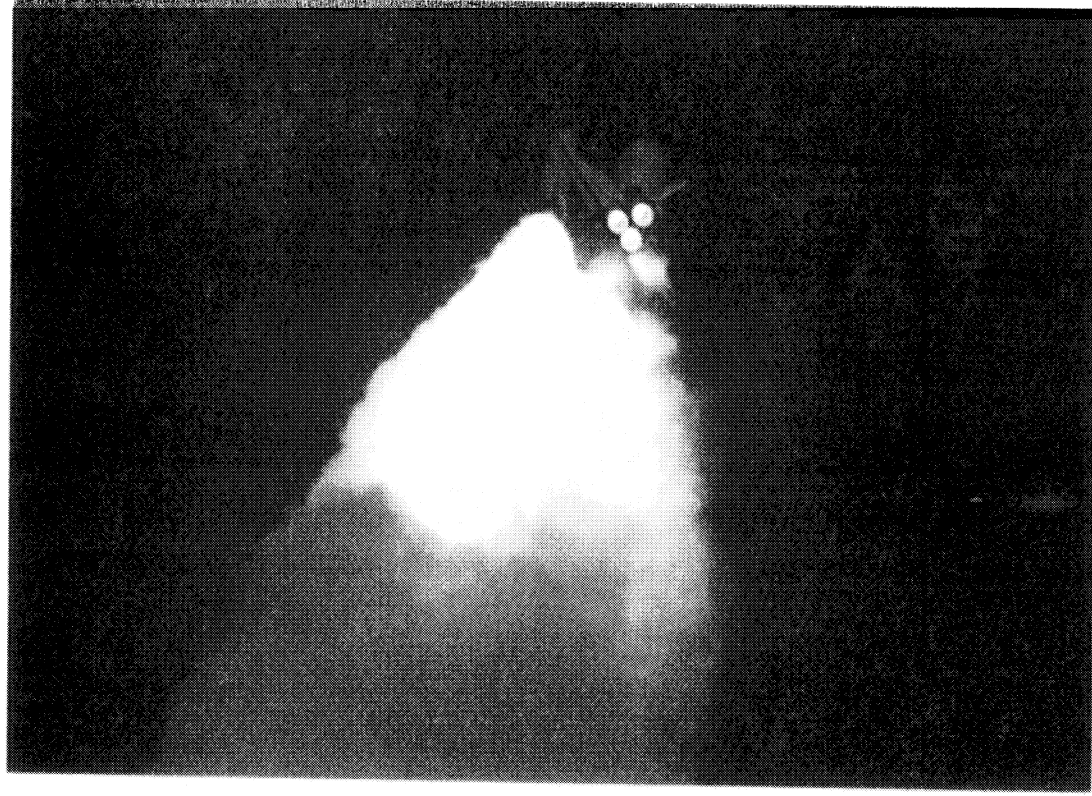
A flash occurred in the SSME plume at 43 seconds MET

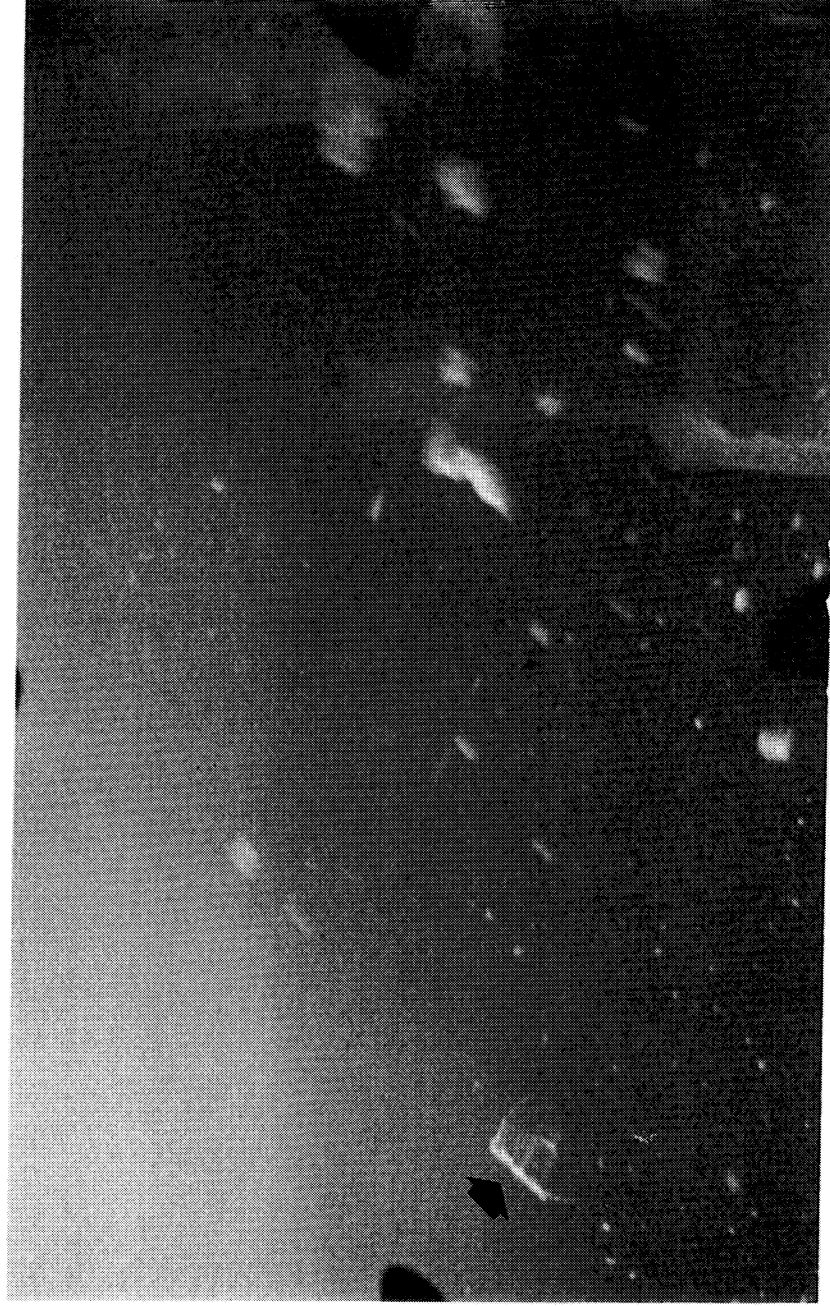
Some of the TPS from the ET intertank divots exhibits dark rind  
or isochem, as well as structural impressions

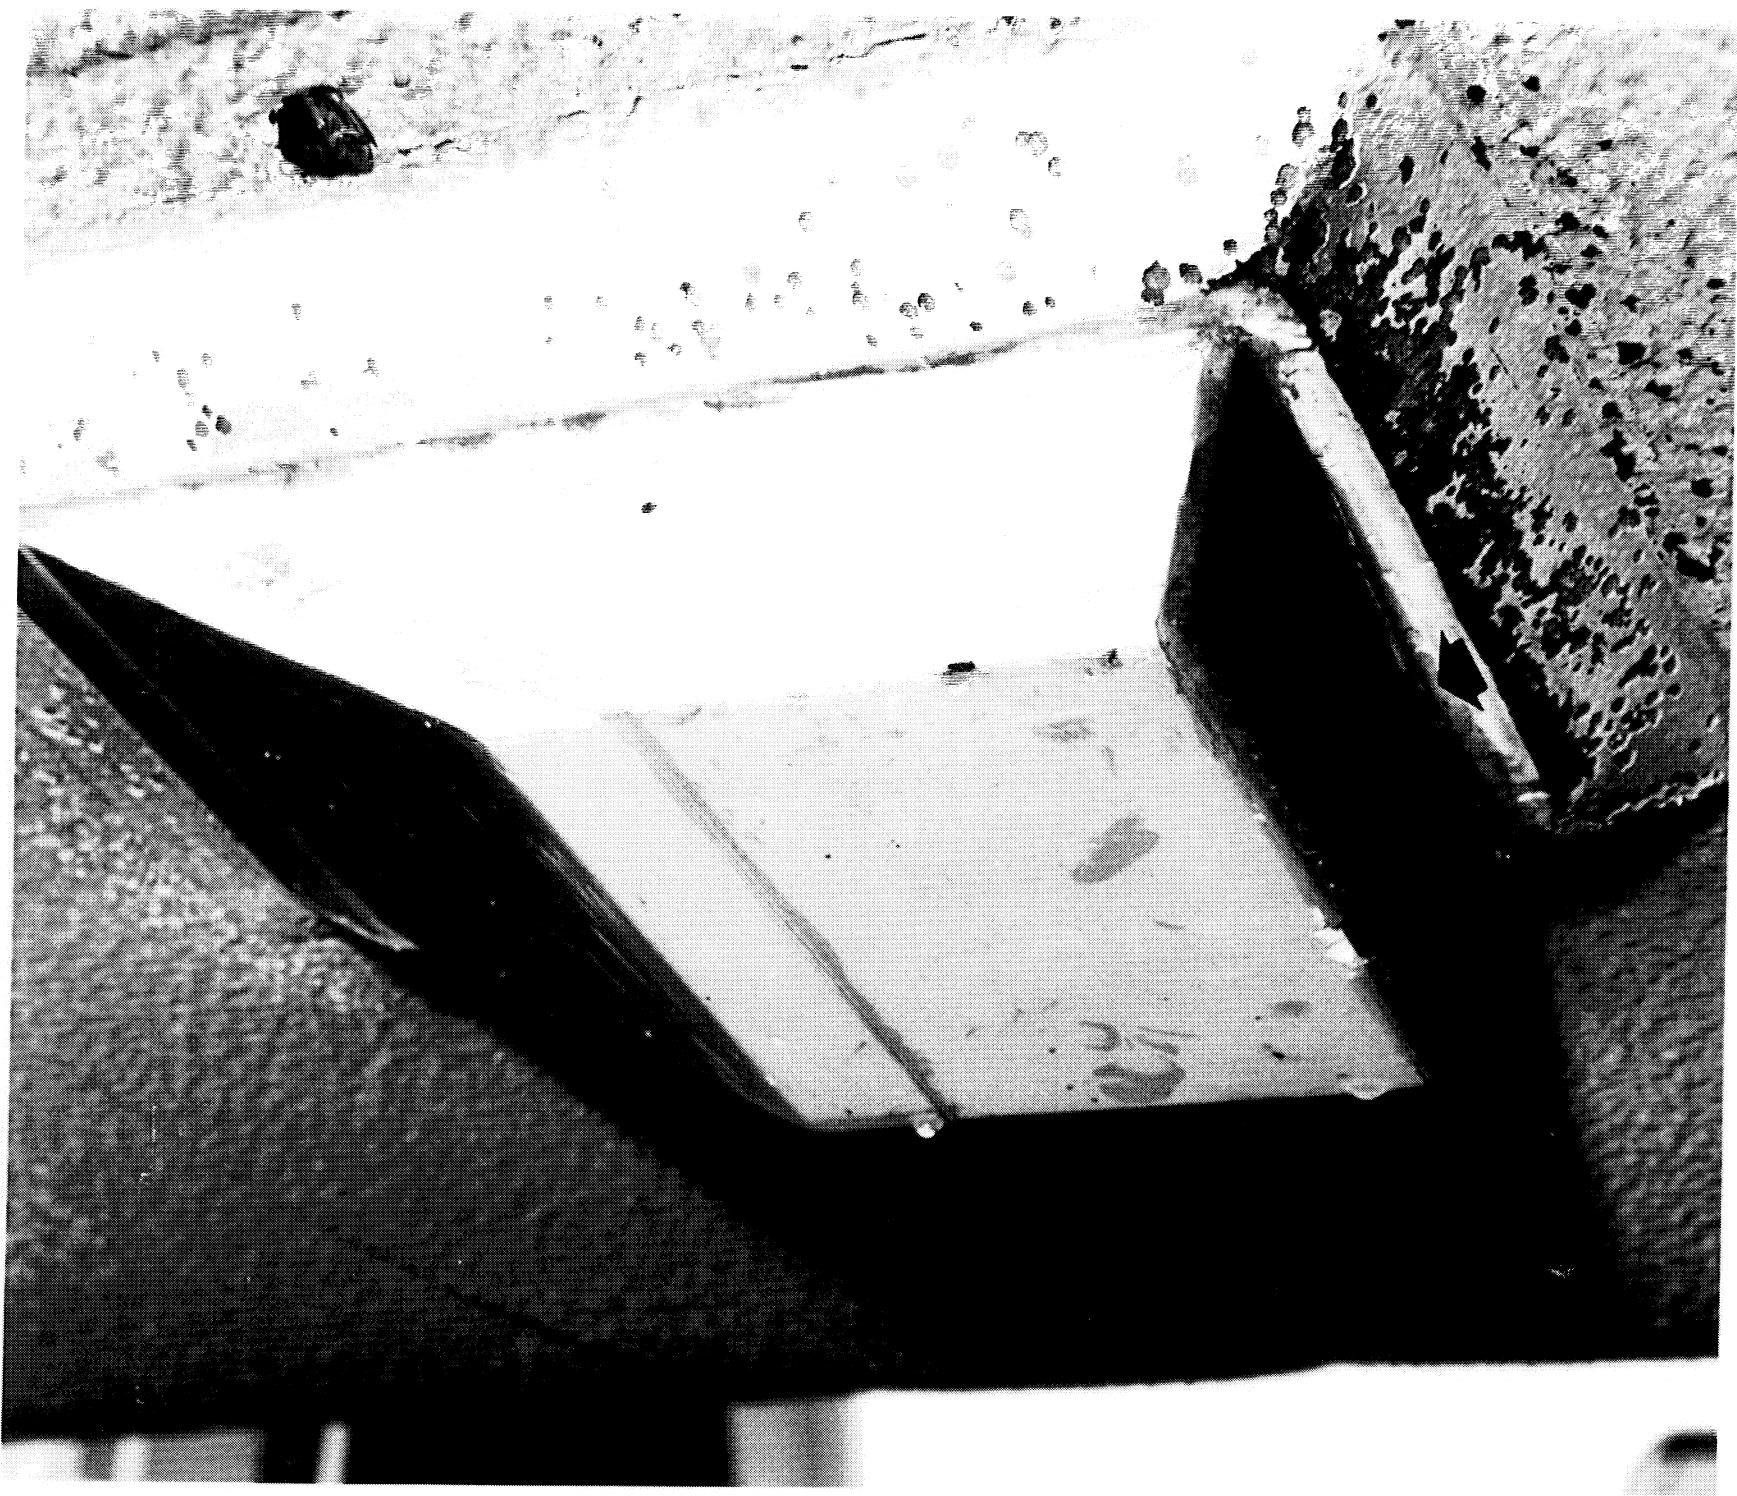
LH SRB +Z RSS antenna phenolic plate lost some material  
from the delaminated layers

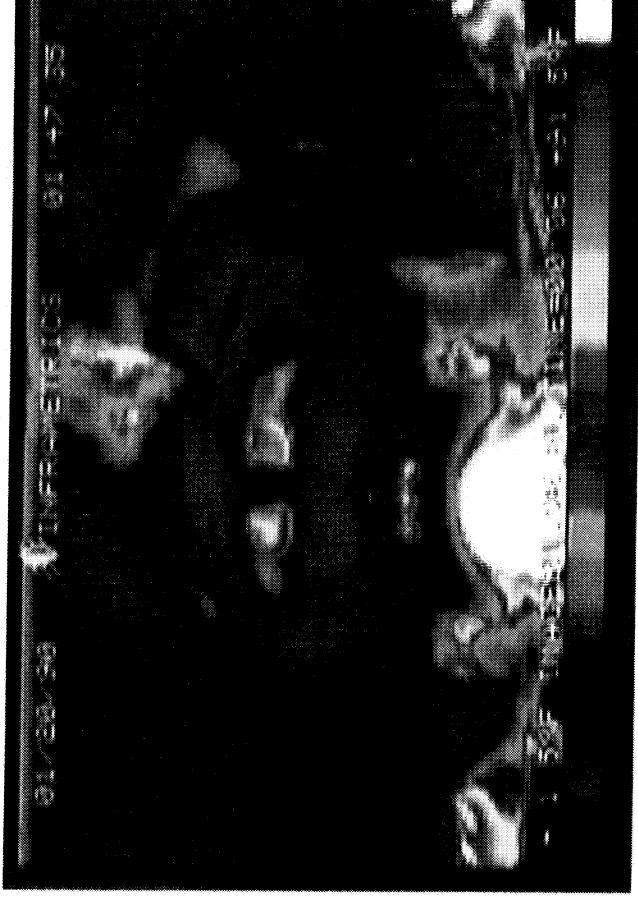
Colorized STI thermal images show warm areas on RCC nosecap,  
wing leading edge, and AFU exhaust ports near base of tail.
